# Allied-Axis

THE PHOTO JOURNAL OF THE SECOND WORLD WAR

## Karl-Gerät 040 at the front

Panzerjäger I • SdKfz. 10 1-ton halftrack  
U.S. M2 Treadway Bridge • PzKpfw. IV Ausf. A  
Type 97 Japanese medium tank

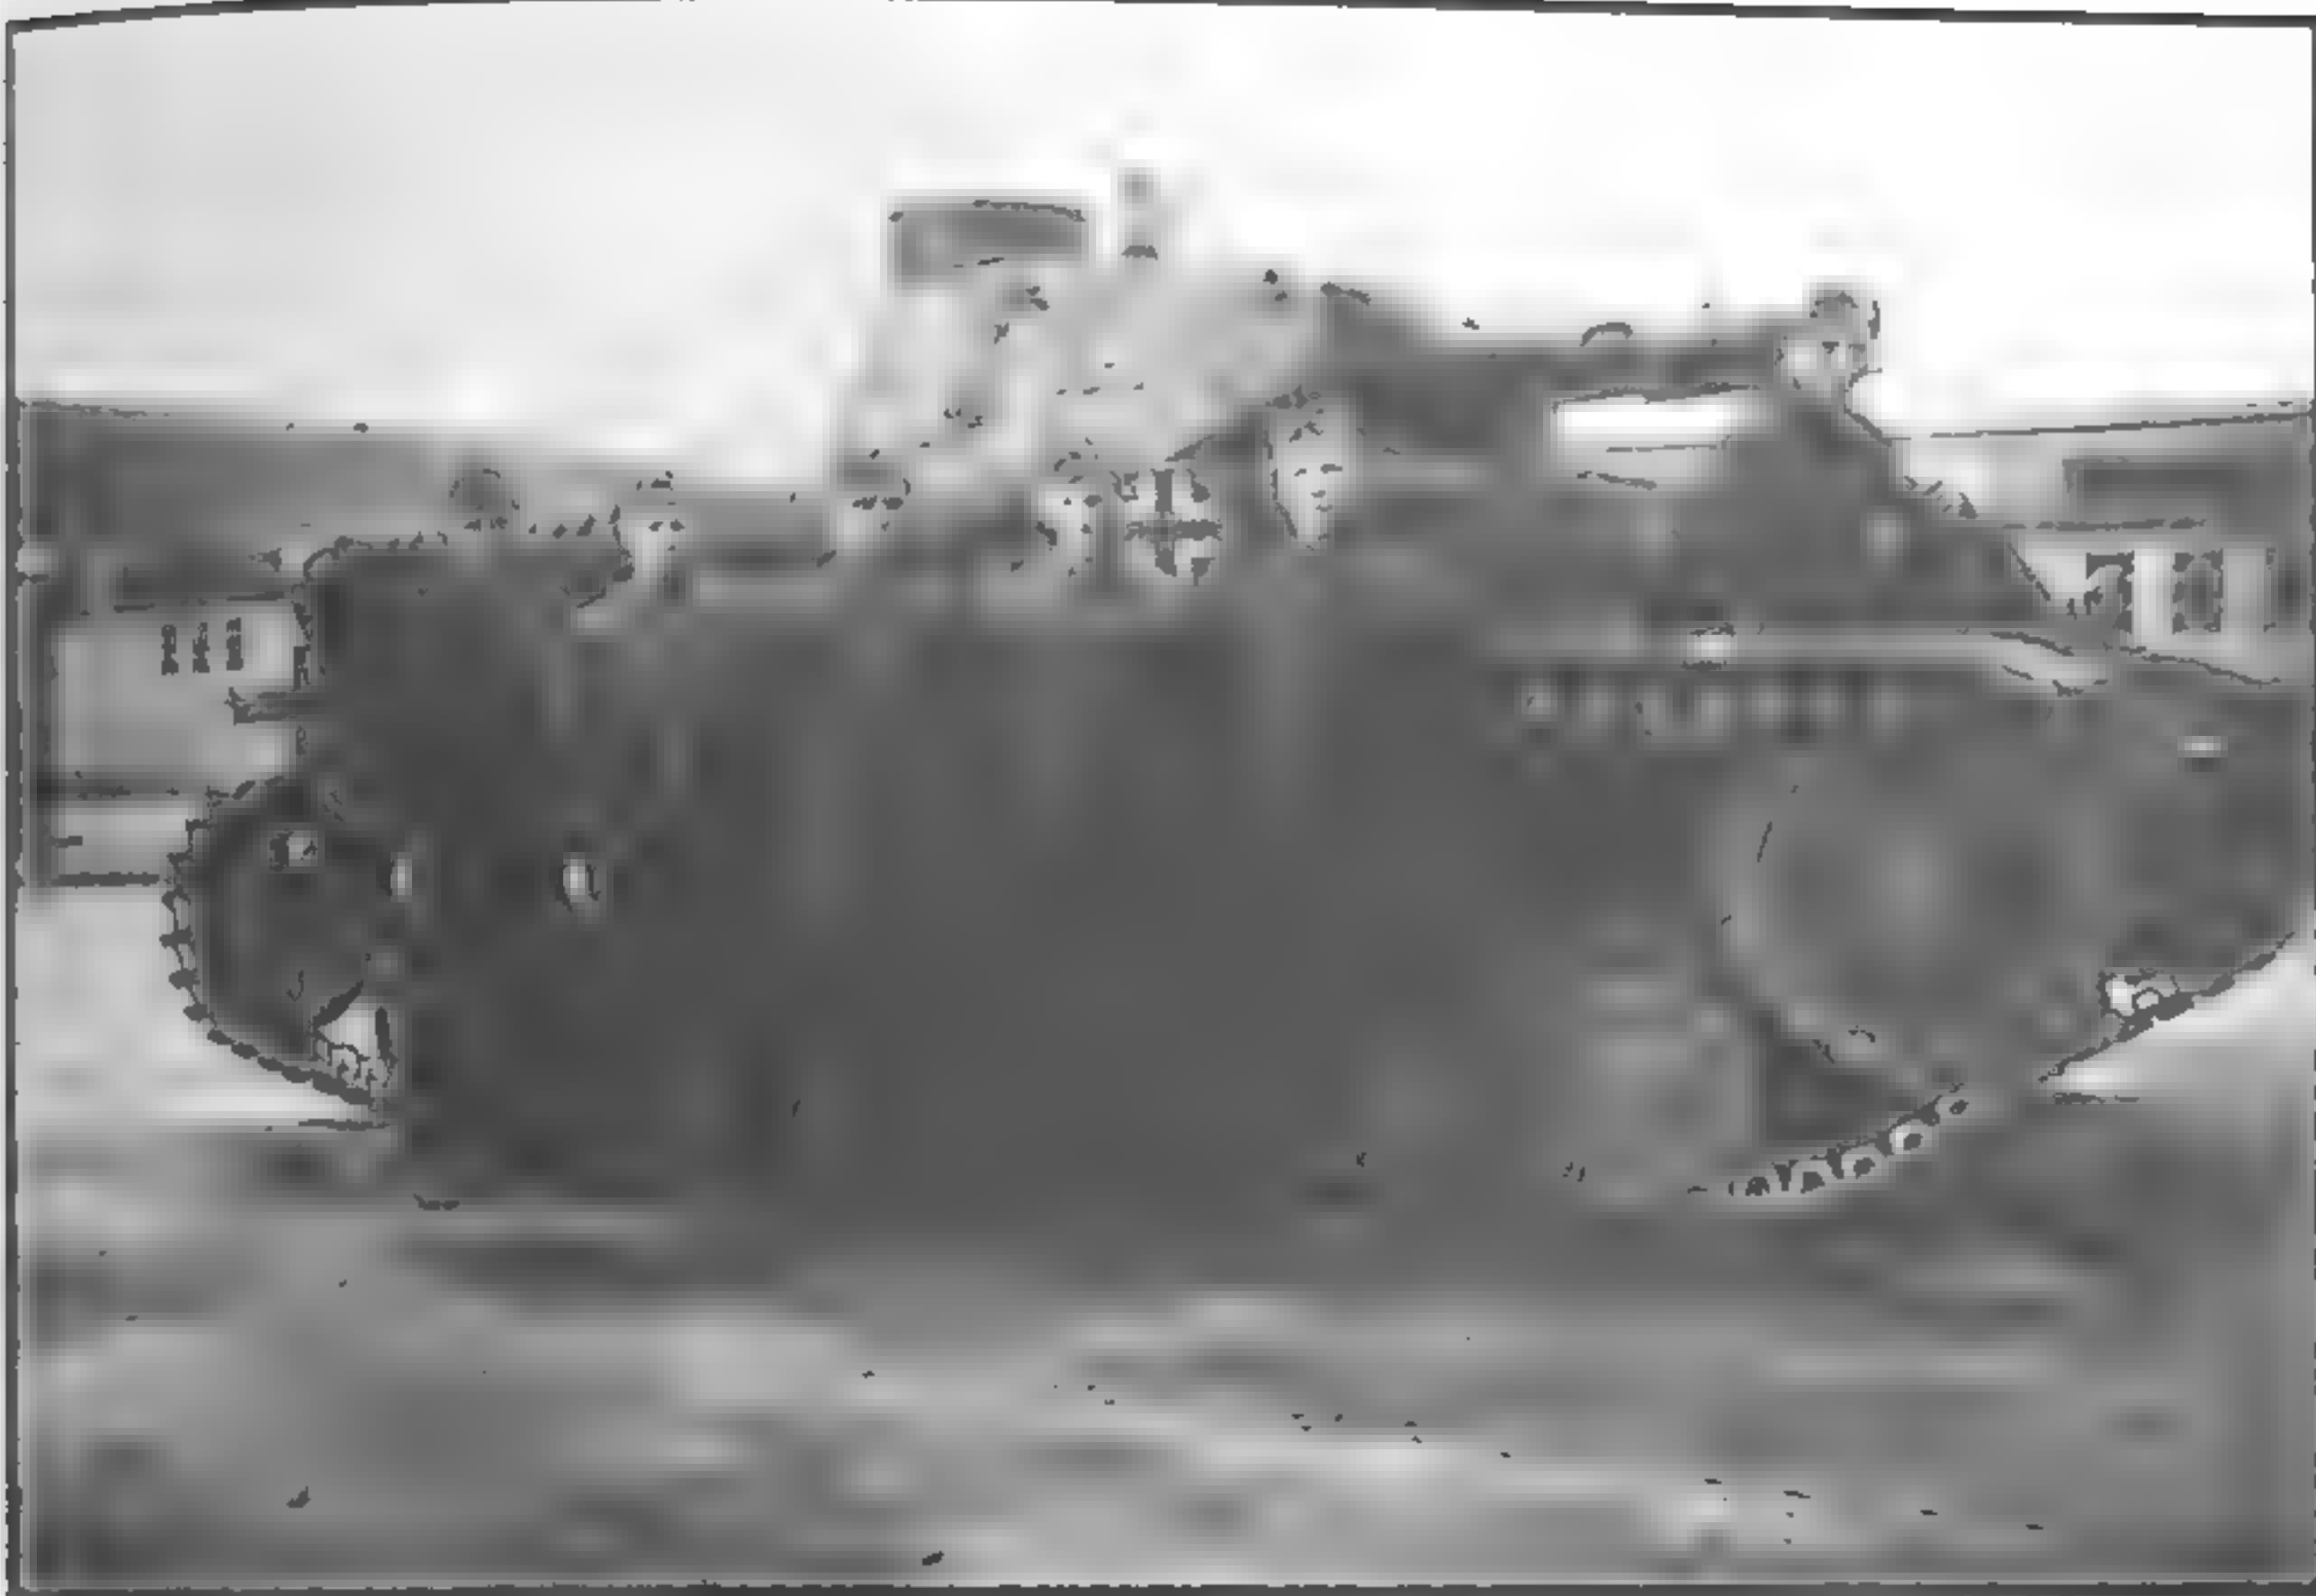
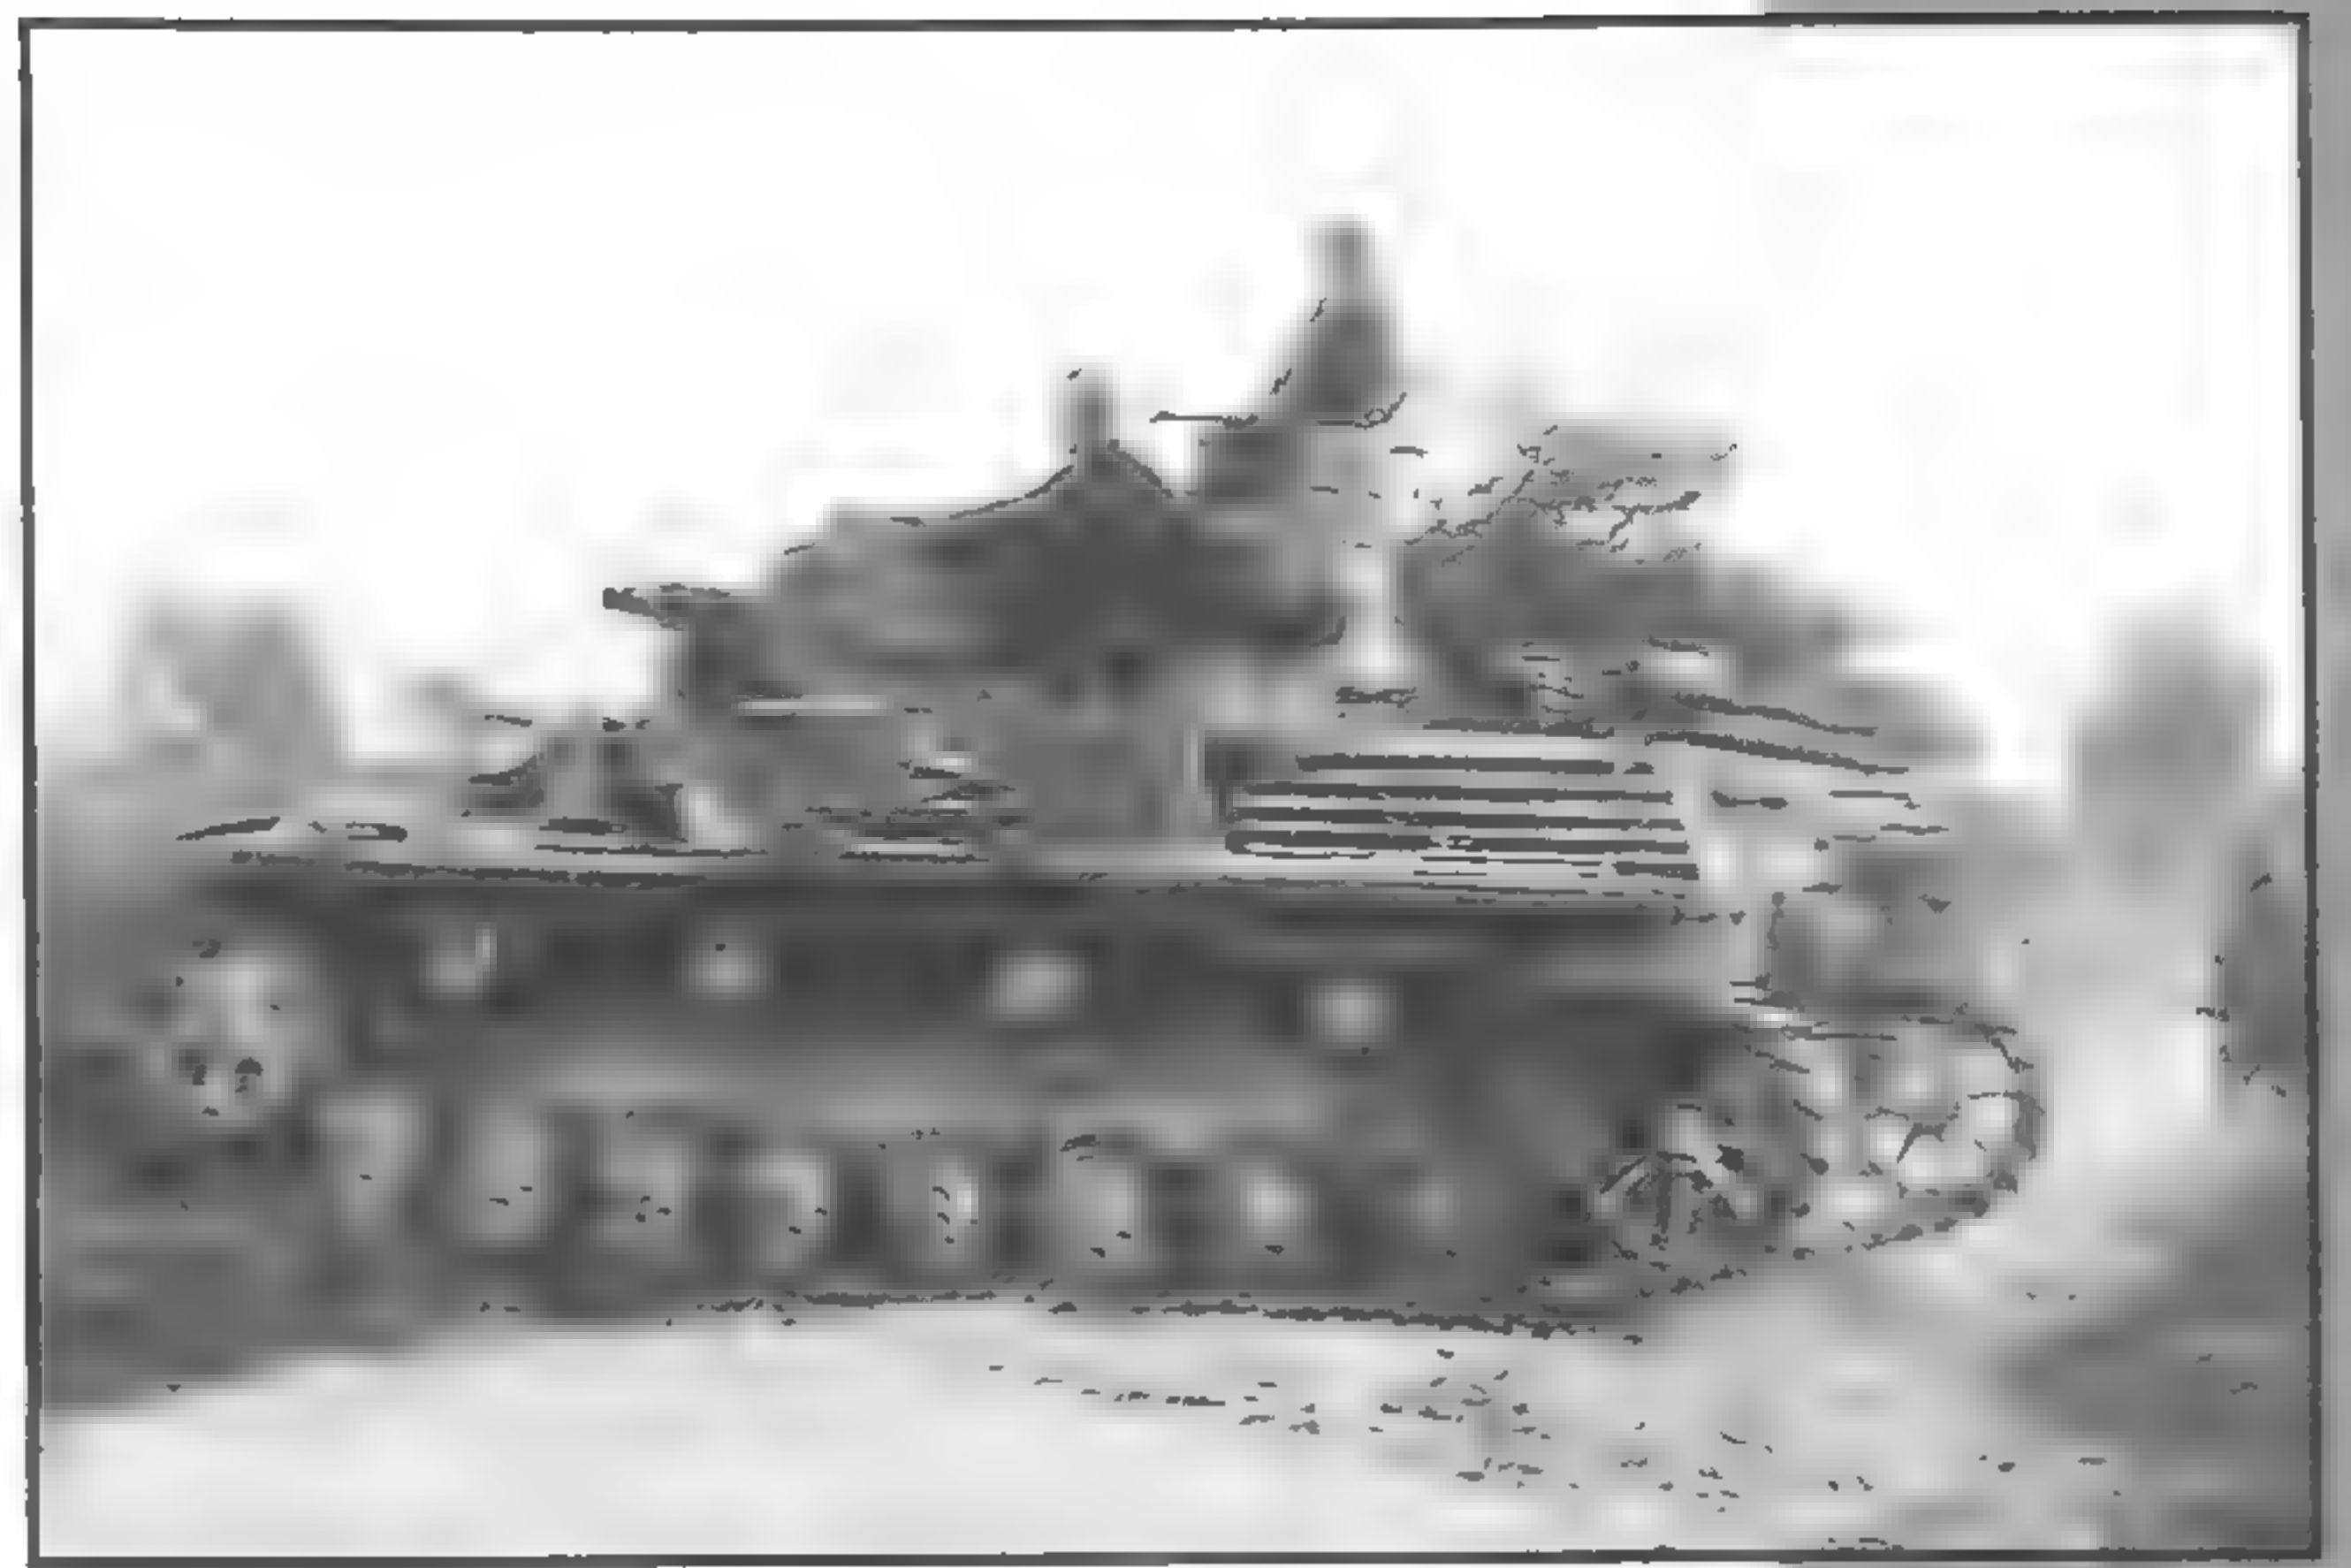
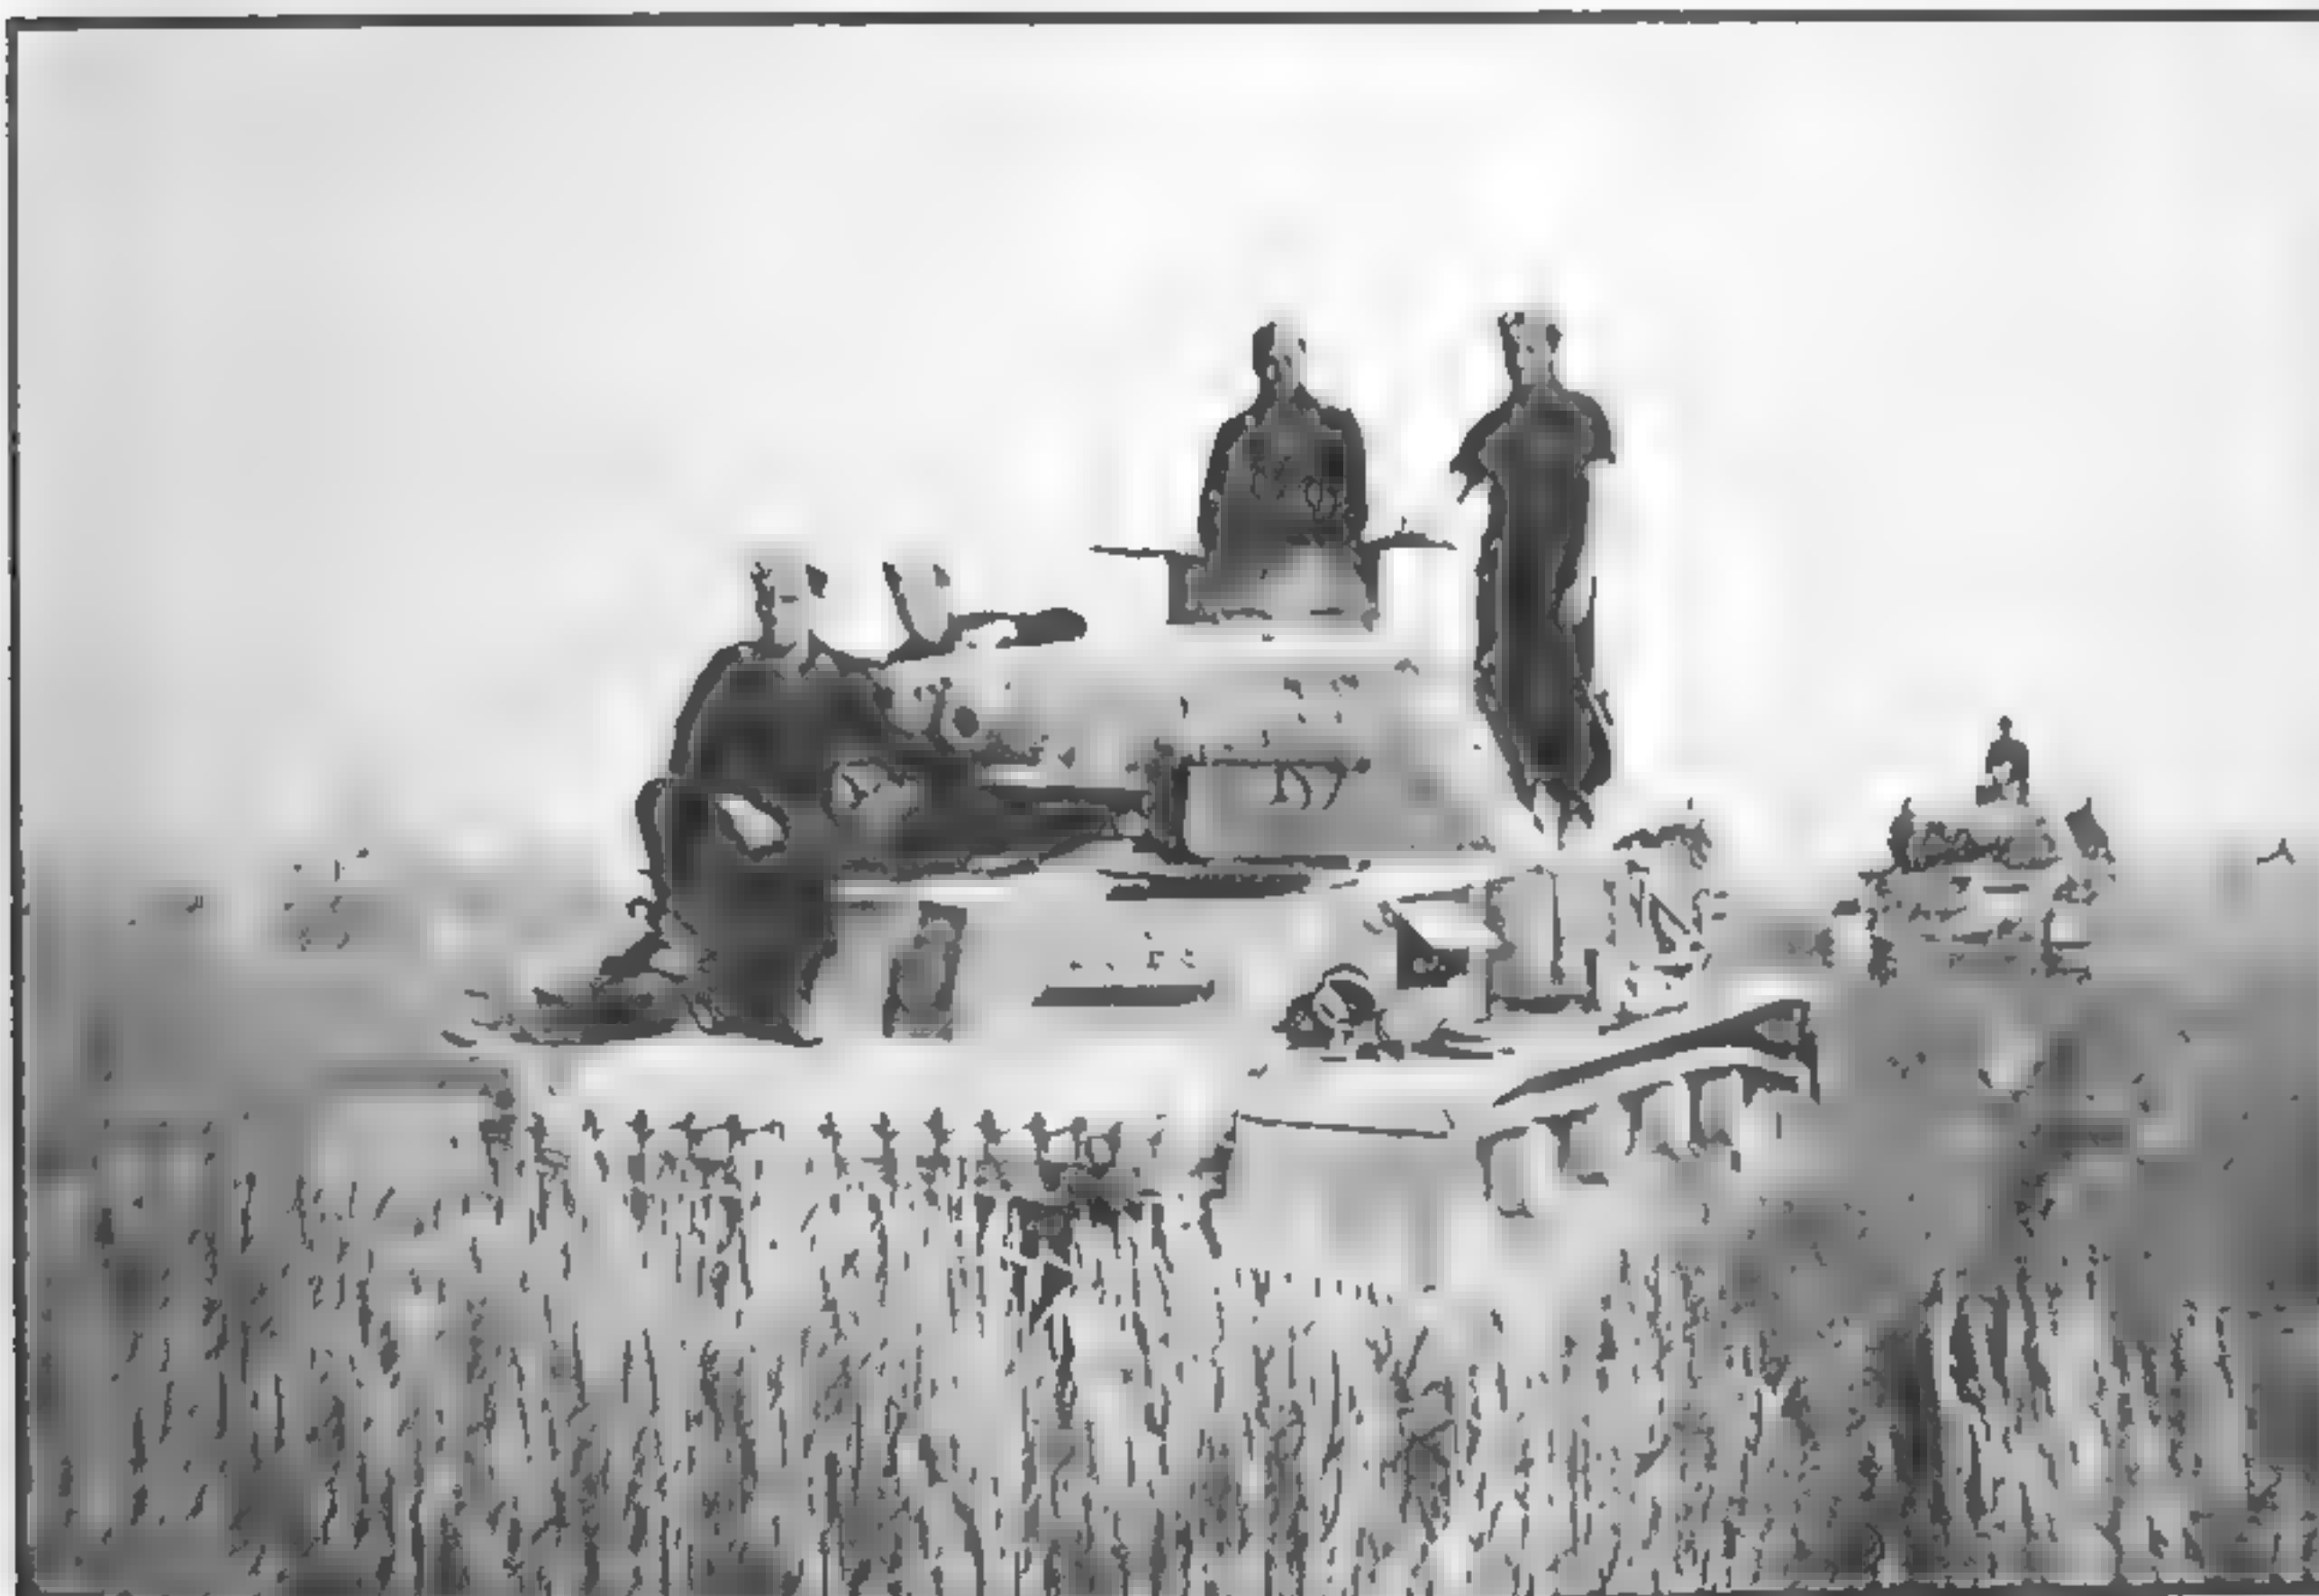
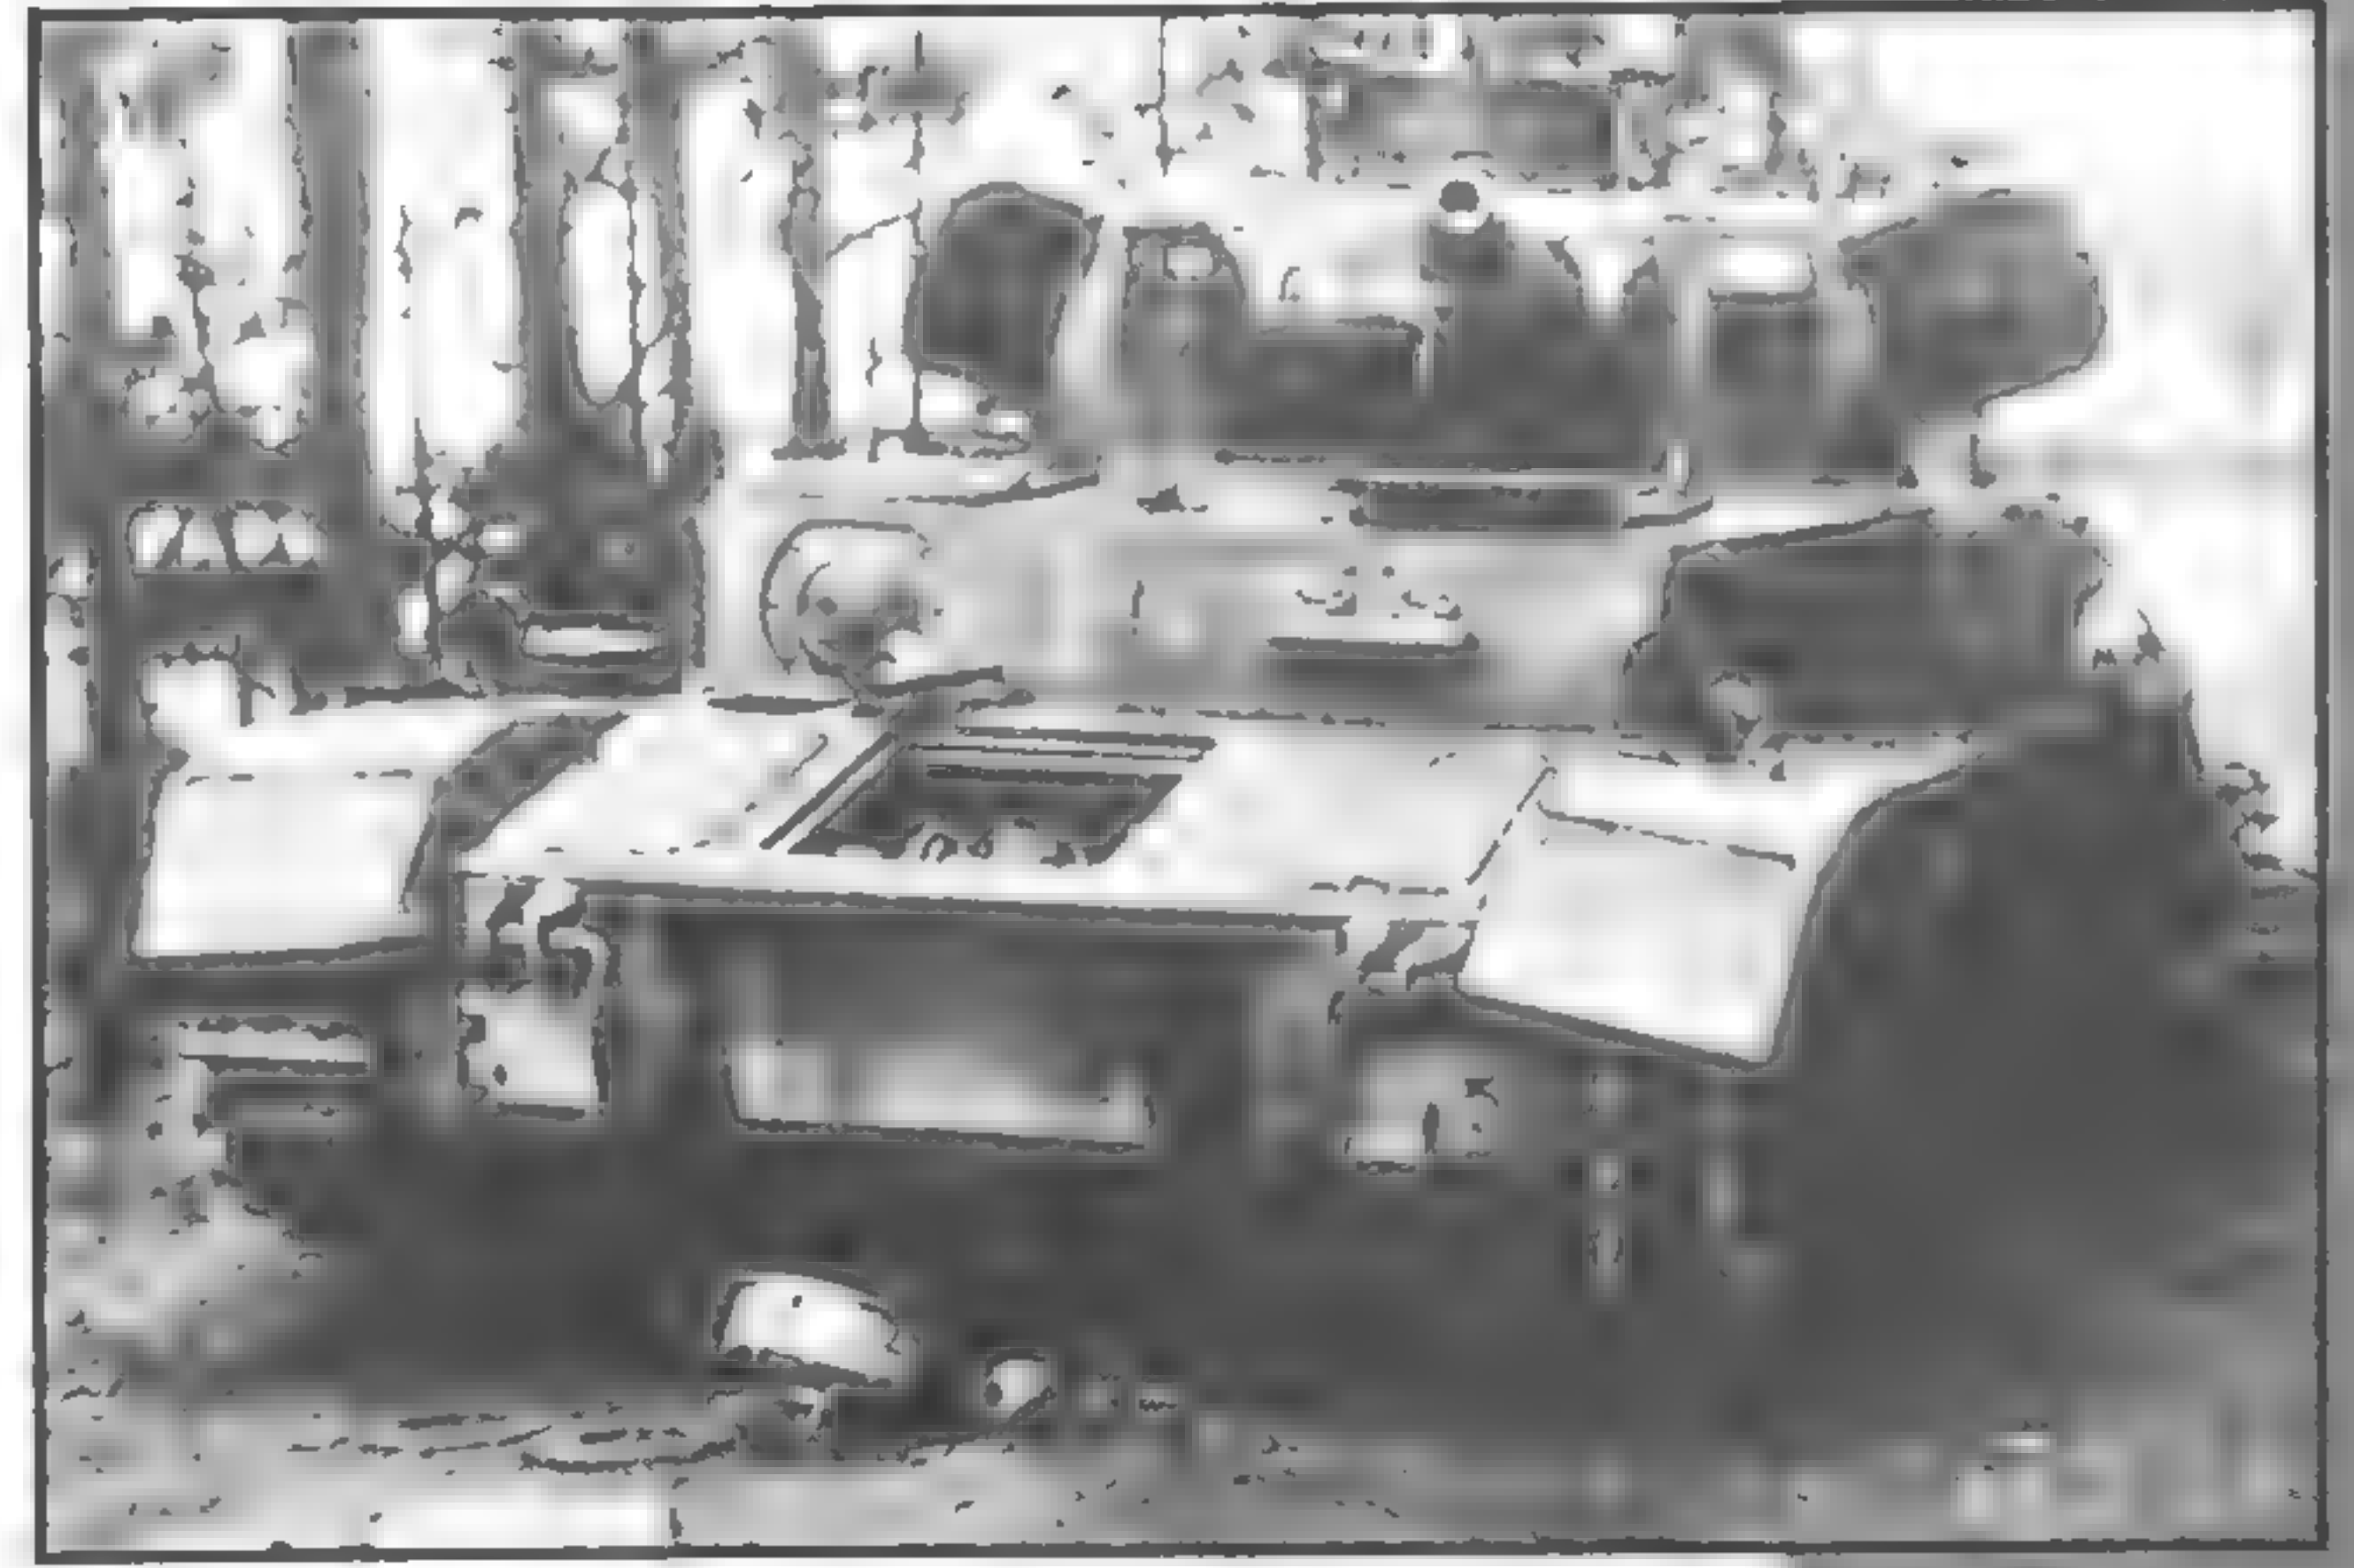
**Top left:** Photographed in the garrison of Wunstorf, the crew of this Ausf. A poses for a photo. Prior to the western campaign, large white numbers were painted on the turret sides. (Photo v. Aufsess) **Top right:** This Ausf. A passes infantrymen during Operation Barbarossa. The escape hatch covers the vehicle's main entrance. (Photo König) **Above left:** Again two Ausf. A vehicles of Pz Rgt 1 or 2 of the 1. Panzerdivision. This photo was taken during seizure of the Weygand line, May 1940. The crew has

added a long section of spare tracks to the tank's bow, possibly to reinforce the thin frontal armor. (Photo A. Takiguchi) **Above right:** This Ausf. A met its fate in Russia; the unit again is unknown. This vehicle is interesting, since it shows additional 30mm plates back fitted to the front. The deflector below the gun is of a later type as well. (Photo Foto-Archiv)

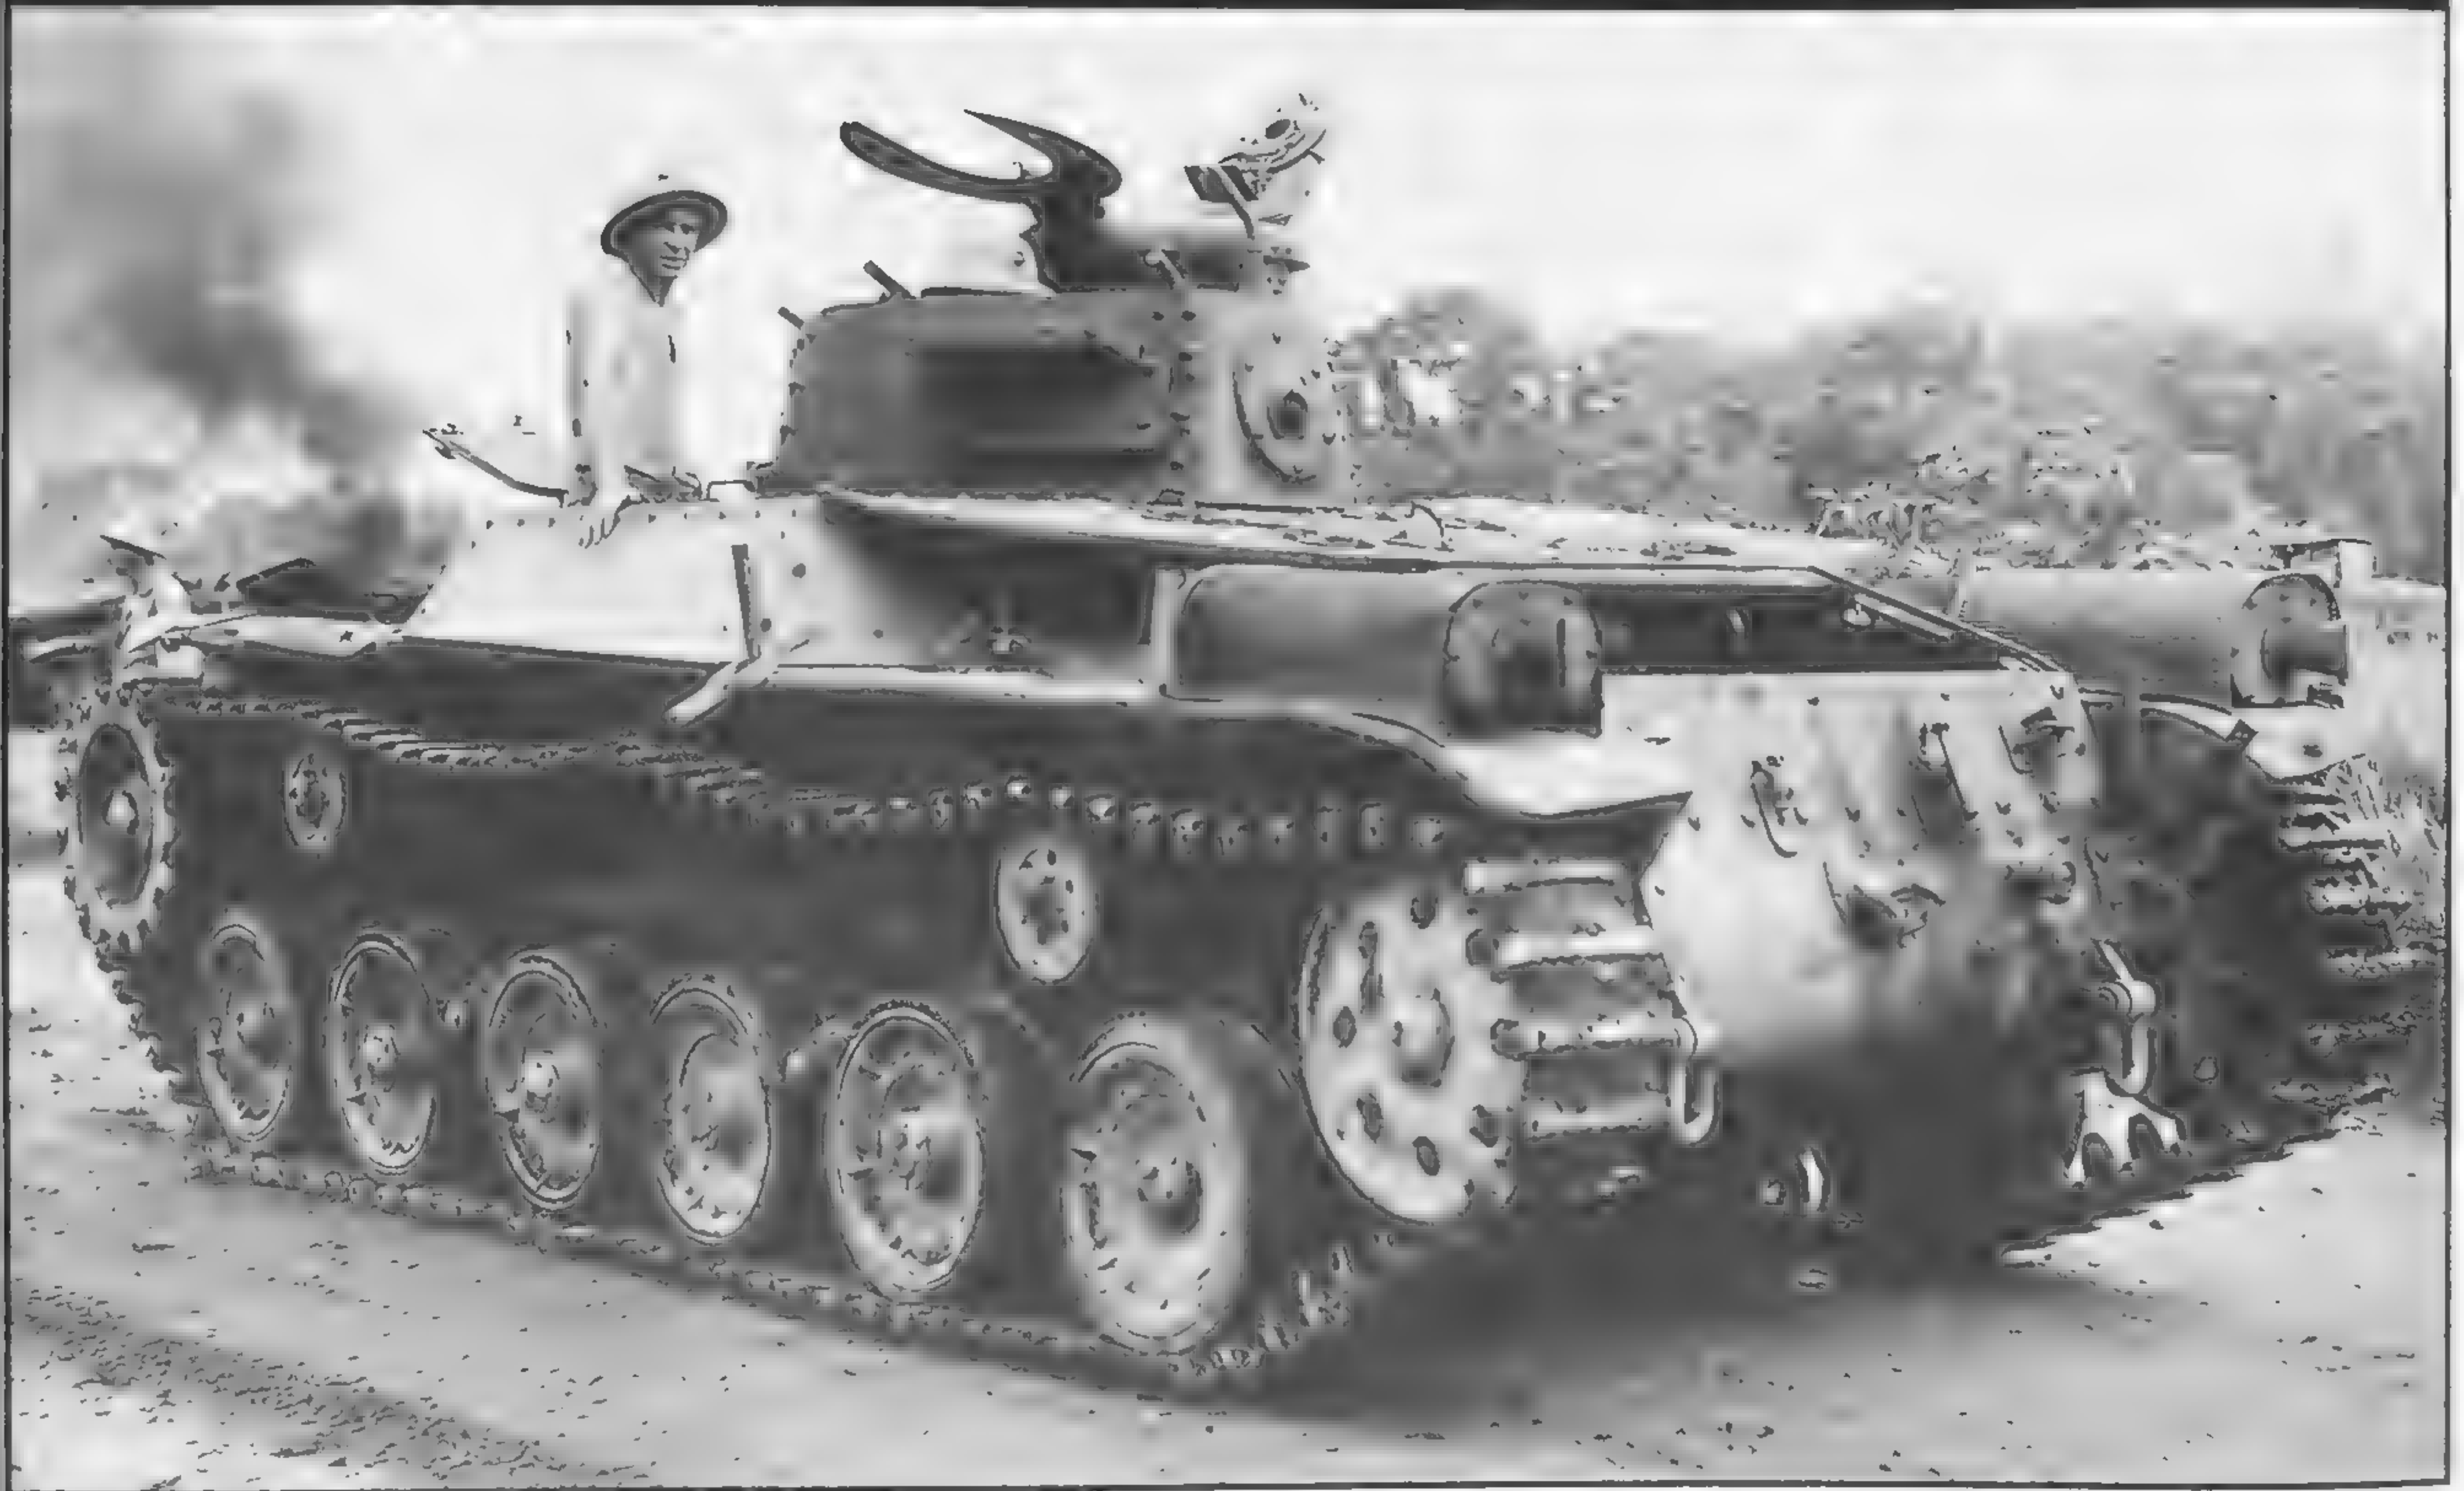
The first medium tank the Japanese developed and produced was the Type 89. Even as it was being deployed it was recognized that a more capable successor was needed. Two different designs were considered as replacements. One was the Chi-Ni, which was lighter and cheaper than the second candidate, Chi-Ha. At first the Chi-Ni was the favorite, but when full-scale war broke out in 1937 it was

decided that the 'Chi-Ha' was the better choice. The 'Chi-Ha' was standardized as the main medium tank for the Japanese during WWII and was designated the Type 97. **Above.** Under new management. This Type 97 also has the smoke canister mount on the turret side. There is also an empty anti-aircraft machine gun mount on the turret roof. (NARA)

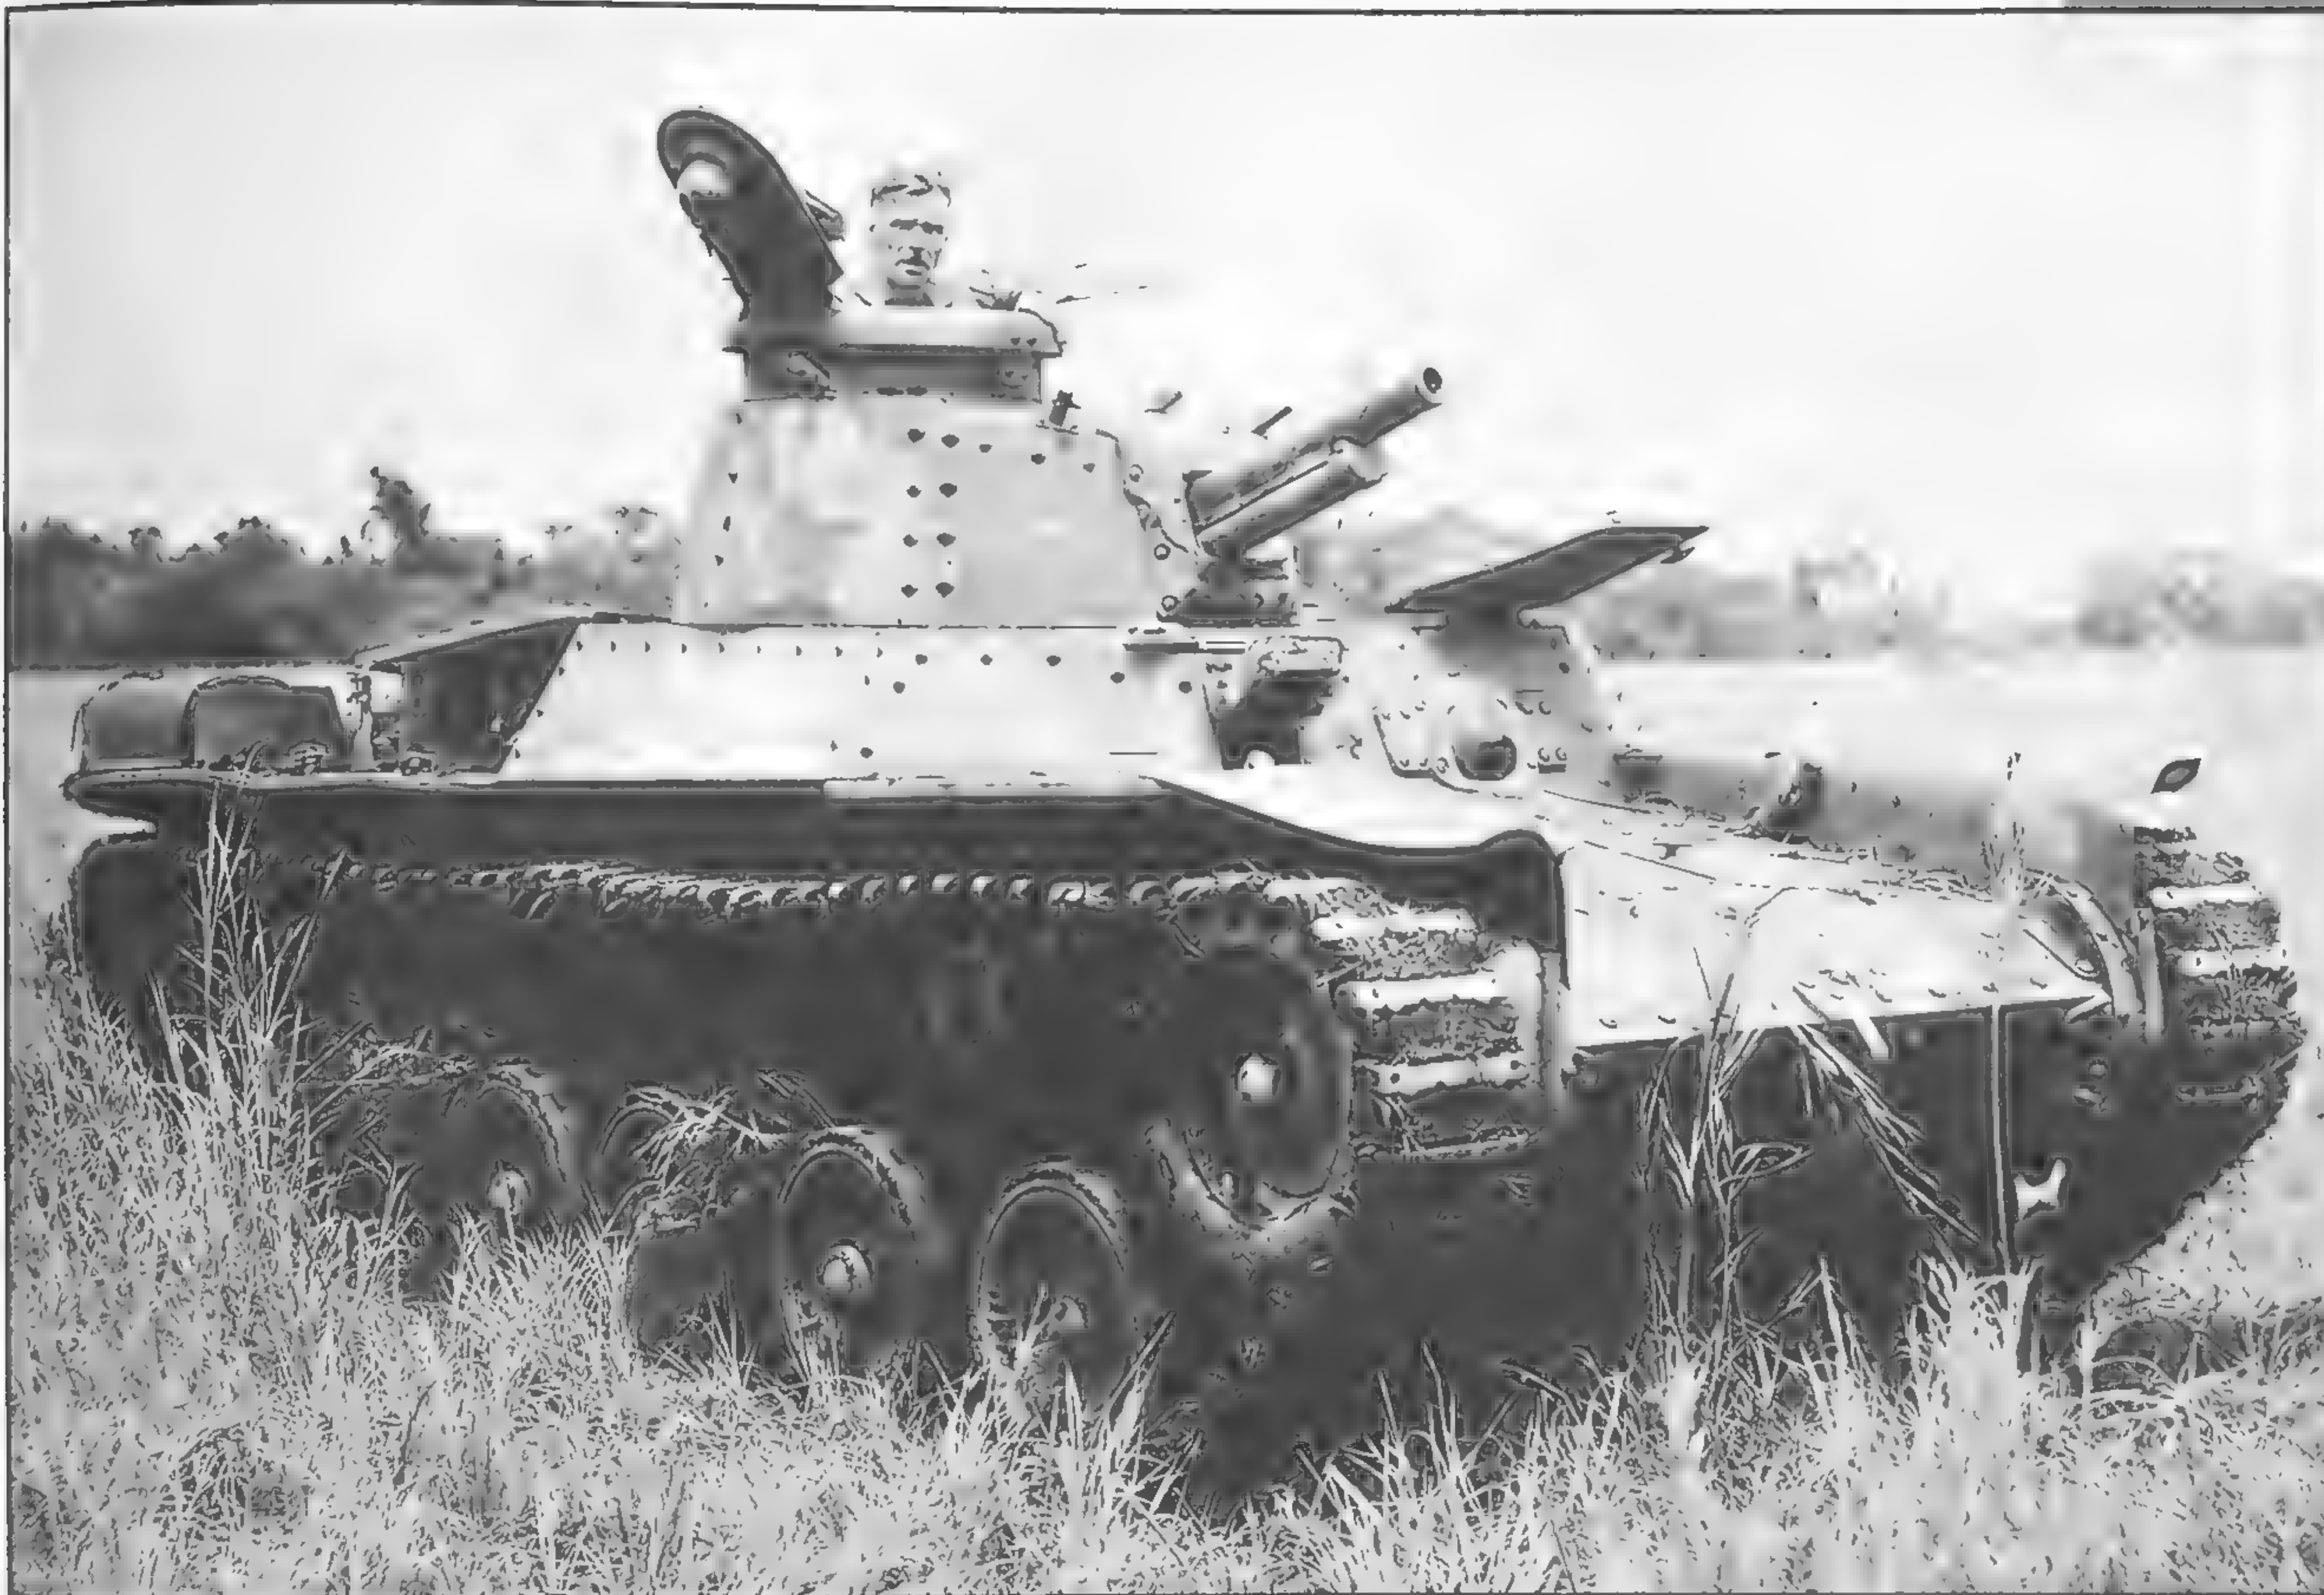
... considered obsolete by the time war started with the United States. It served throughout the war. The Type 97 was the most powerful and heavily armed Japanese tank at the beginning of WWII. It was a serious challenge to the USMC and Army Shermans. Its armor was very thin at first but was later upgraded. The main armament was the Type 97 57mm gun, plus two 7.7

machine guns and it had a crew of 4. **Above.** On this Type 97 the antenna has been removed but pieces of some sort have been fitted to close the mount tubes. Notice the short rod on the left side, lying down. This is part of the auxiliary antenna that was sometimes mounted. (NARA)
